Technical Information

01/2018

911 GT3 Cup (997)

Drive shaft

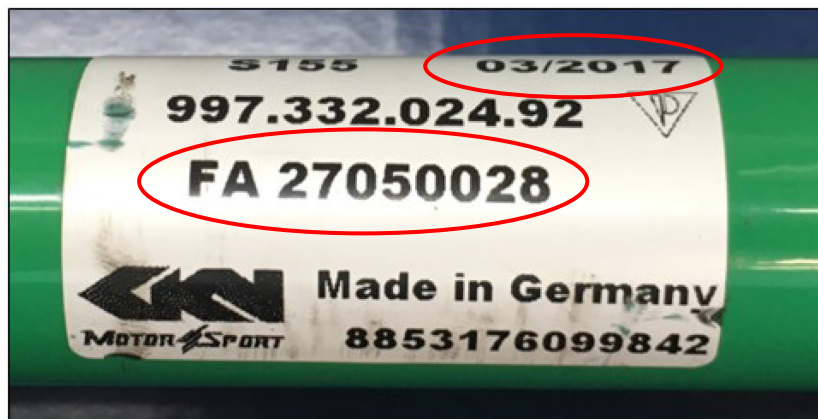
Zur Identifizierung der betroffenen Bauteile muss die Chargen-Nr. und das Fertigungsdatum auf dem Aufkleber der Gelenkwelle abgelesen werden:

Bild 1: Aufkleber auf Schaft der Gelenkwelle zur Bauteil-Identifizierung

Porsche Motorsport weist darauf hin, dass es bei der Herstellung der unten genannten Gelenkwellen zu Auffälligkeiten bzgl. Materialqualität gekommen ist. Aus diesem Grund empfiehlt Porsche Motorsport bei den betroffenen Chargen **27050028 – 03/2017 & 27050847 – 05/2017** die radseitigen Gelenkzapfen der Gelenkwelle vom Hersteller nacharbeiten zu lassen.

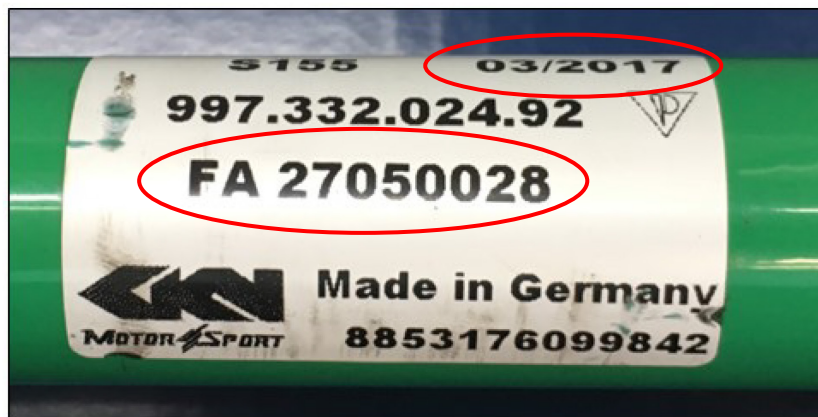
To identify the affected parts the batch & production number is visible on the label attached to the driveshaft.

Picture 1: Sticker on drive shaft for part identification

Porsche Motorsport points out that during the manufacturing process of the below mentioned drive shaft material abnormalities were seen. Due to this fact, Porsche Motorsport recommends a rework of the affected parts of batch no. **27050028 - 03/2017 & 27050847 - 05/2017** to replace the outer pinion.
